DEPARTMENT OF TRANSPORTATION

Contract #: 04-0120F4Cty: SF/ALA Rte: 80 PM: 13.2/13.9File #: 1.28**WELDING INSPECTION REPORT****Resident Engineer:** Casey, William**Address:** 333 Burma Road**City:** Oakland, CA 94607**Report No:** WIR-026699**Date Inspected:** 07-Nov-2011**Project Name:** SAS Superstructure**OSM Arrival Time:** 600**Prime Contractor:** American Bridge/Fluor Enterprises, a JV**OSM Departure Time:** 1630**Contractor:** American Bridge/Fluor Enterprises, a JV**Location:** Job Site**CWI Name:** See Below**CWI Present:** Yes No**Inspected CWI report:** Yes No N/A**Rod Oven in Use:** Yes No N/A**Electrode to specification:** Yes No N/A**Weld Procedures Followed:** Yes No N/A**Qualified Welders:** Yes No N/A**Verified Joint Fit-up:** Yes No N/A**Approved Drawings:** Yes No N/A**Approved WPS:** Yes No N/A**Delayed / Cancelled:** Yes No N/A**Bridge No:** 34-0006**Component:** OBG**Summary of Items Observed:**

WELDING INSPECTION REPORT

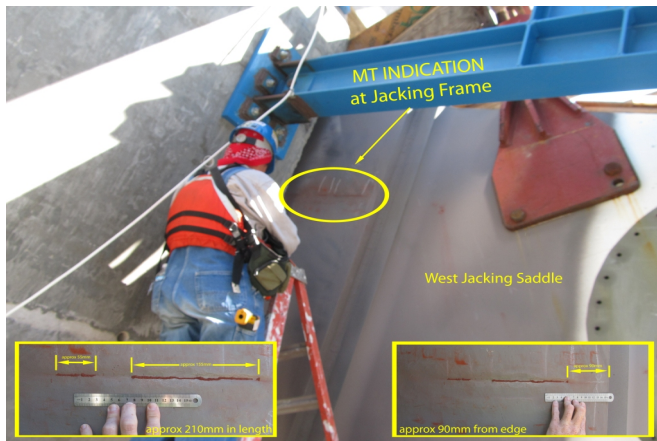
Structures Representative, Douglas Wright, contacted this QALI in regards to a linear indication observed on the jacking frame located at the west end of the W2 bent. This QALI performed a visual inspection of the area and concurred with Mr. Wright. At this time, Structural Materials Representative (SMR) Kit Guest was present at this time and contacted QA Supervisor, William Levell to inform him of this issue. This QALI contacted QC Lead Inspector Bonifacio Daquinag, Jr. and informed of this issue and shortly thereafter, Mr. Daquinag, QC inspector's Jesse Cayabyab and Bernie Docena arrived at this location. Mr. Daquinag directed the QC inspector's to perform a Magnetic Particle Test (MPT) of the area and at the conclusion of the test two (2) linear indications were revealed and appeared, accordingly, to be approximately 50 mm-long and 190 mm-long. At this time Mr. Daquinag informed this QALI that he would contact Leonard Cross, Quality Control Supervisor, to request a directive of how to proceed.

See the digital photograph below illustrates some the related work observed during this shift.
